FINAL REPORT

AN/SPS-57 RADAR IMPROVEMENT PROGRAM, PHASE II

February 1977

Prepared for  
U.S. COAST GUARD  
400 7TH STREET, N.W.  
WASHINGTON, D. C. 20590  
under Contract DOT-CG-52488-A

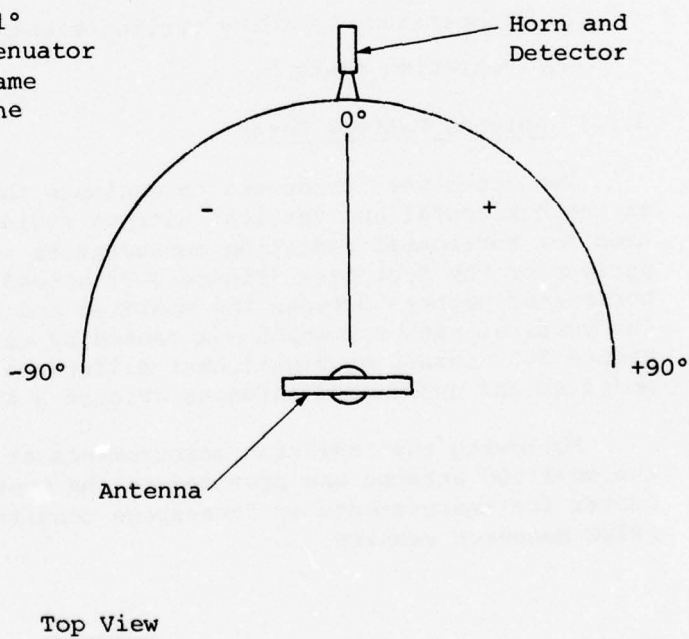
Figure 3-1. EQUIPMENT SET UP FOR HORIZONTAL ANTENNA PATTERN TEST

Note: Antenna was turned in  $1^\circ$  increments and the attenuator adjusted to give the same reference reading on the indicator.

Two tests were conducted to evaluate the effect of the modifications on the horizontal and vertical antenna radiation patterns. The test setup used for horizontal radiation measurements is shown in Figure 3-1. A comparison of the test data (Figure 3-2) showed only minor variations in the horizontal pattern between the modified and unmodified antennas. Similarly, the vertical pattern, which was tested by using the setup illustrated in Figure 3-3, showed no significant difference in radiation between the modified and unmodified antennas (Figure 3-4).

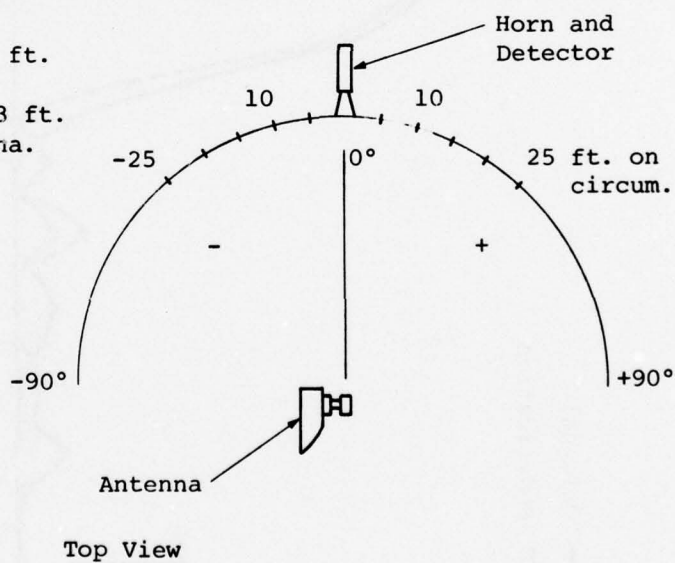
Figure 3-3. EQUIPMENT SET UP FOR VERTICAL ANTENNA PATTERN TEST

Note: The Horn was moved in 1 ft. increments around the circumference of a 38.33 ft. circle around the antenna.

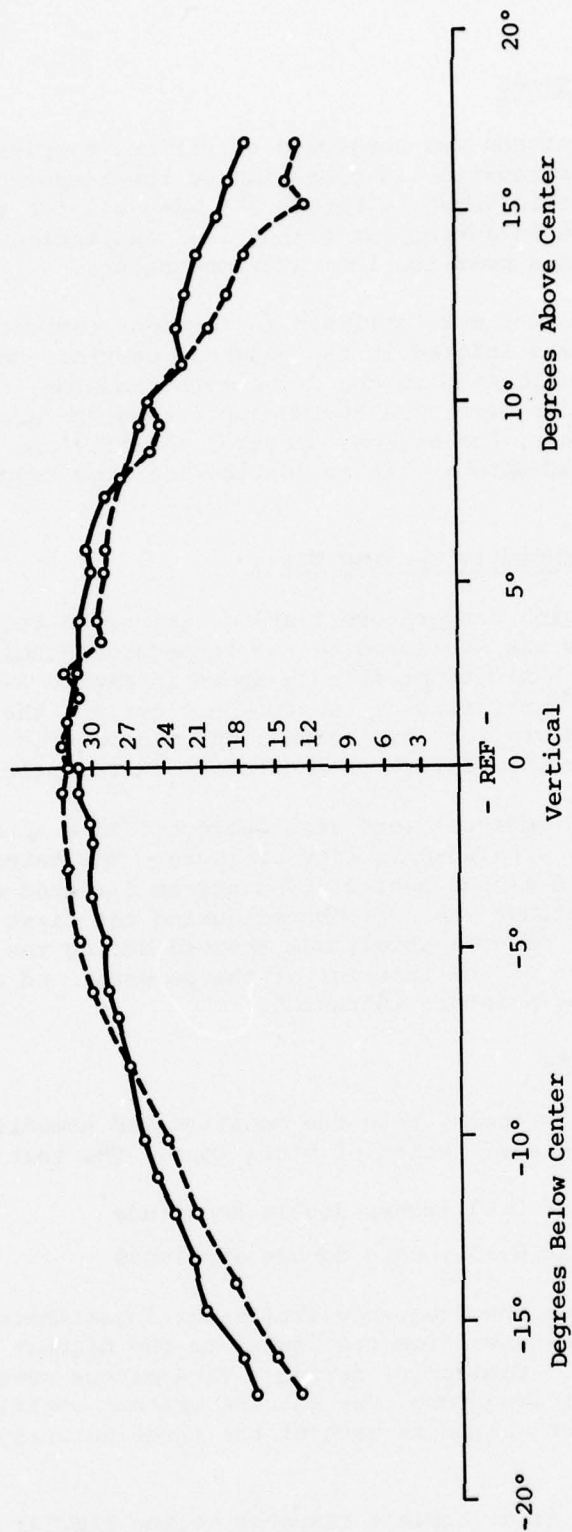
Figure 3-4. VERTICAL RADIATION PATTERNS OF MODIFIED AND UNMODIFIED ANTENNAS

Original  
Modification

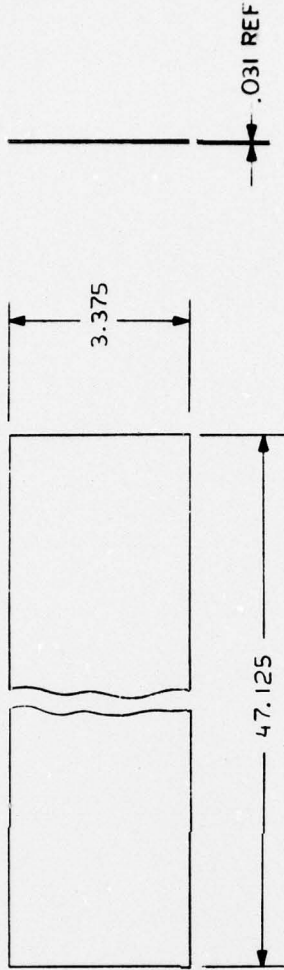
1. MATERIAL - PLASTIC, SHEET, .031 THK  
LAM, FER MIL-P-18177, TYPE GEB

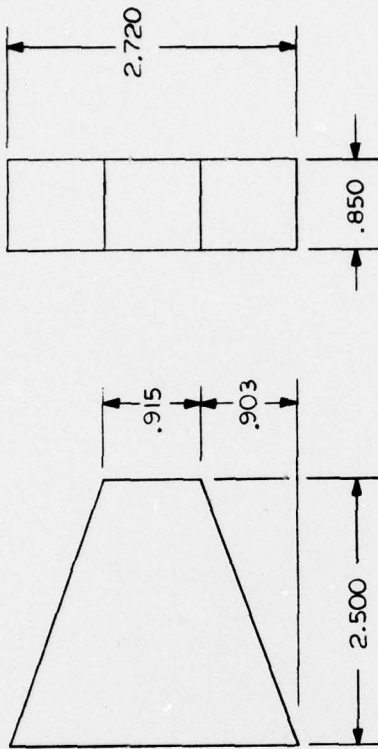
1. MATERIAL - POLYURETHANE FOAM ELASTIC,  
MIL-P-26514, TYPE 1, CLASS 2, 2-4 POUNDS/CU. FT.

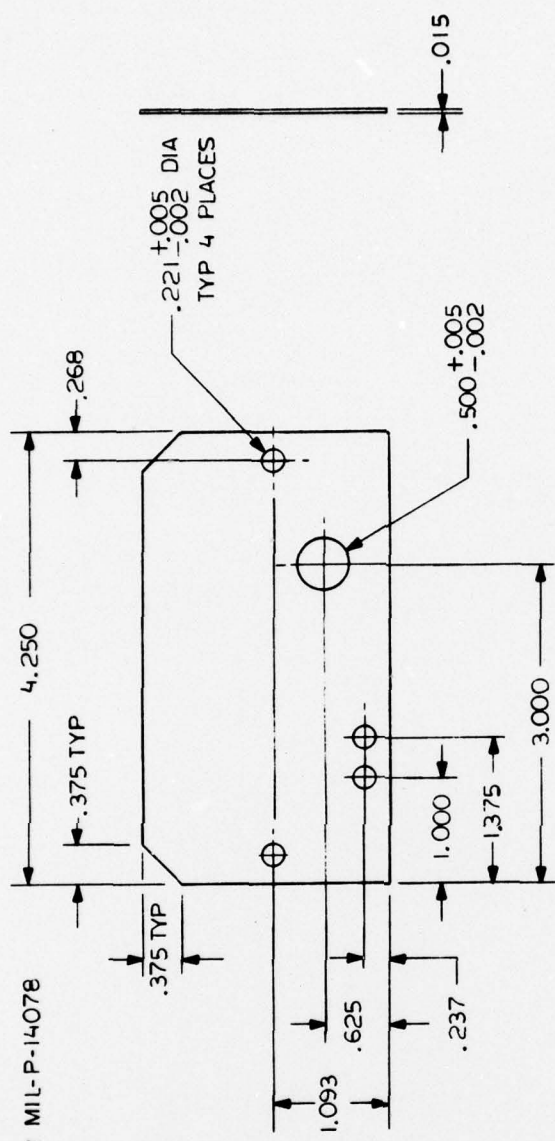
NOTES:  
 1. MATERIAL — TEFLON SHEET PER MIL-P-14078
